THORSEALS AND HPSXL SOLVE WICKET GATE LEAKAGE PROBLEM

Rock Island Dam Hydroelectric Facility located on the Columbia River, Washington, USA

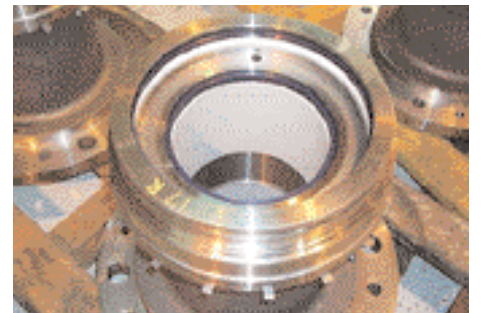
Thordon HPSXL wicket gate bearings with Thorseals

The answer was HPSXL. This is the hardest and stiffest grade of Thordon, featuring the lowest coefficient of friction for less wear and elastomeric qualities for strong performance under edge loading conditions.

The seals selected for the job were Thorseals. These are Thordon's high performance line of tough, abrasive resistant hydraulic cylinder seals providing positive sealing over a wide range of operating pressures. "Due to all the previous sealing problems, I came up with a new double seal design to replace the single seal system," says Anderson. In the new design, the space between the first and second seal was plumbed so that, if leakage did occur, the water could be
