# MAINTENANCE AT INCO GENERATING PLANT NO

# LONGER FRAZZLED BY DOWNTIME CONCERNS

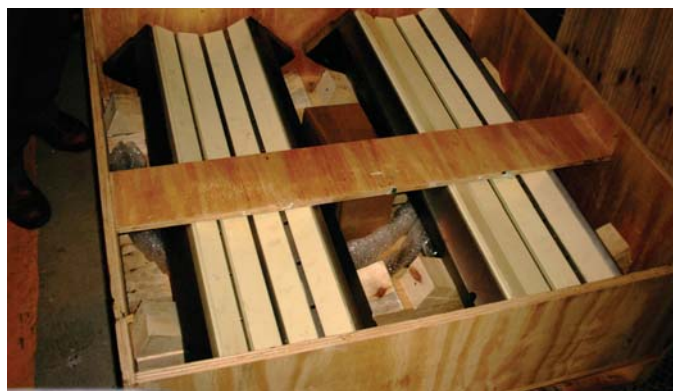
**Split SXL Stave Main Guide Bearing**

To reduce downtime in the future, Thornton and the engineers at Thordon Bearings recommended a stave configuration. This helped reduce the time it would take to remove, service and reinstall the bearings from the current standard of three to four months to just a few days!

stopped five times, each time running dry. The fear was that the bearing would be burnt and require immediate changeout, something that would be expected from a phenolic material. It wasn't. In fact, after inspection, Thordon SXL was only mildly scuffed.

"And the good news is," says Thornton, "Inco's maintenance staff was able to clean the exfoliated material from the water grooves and

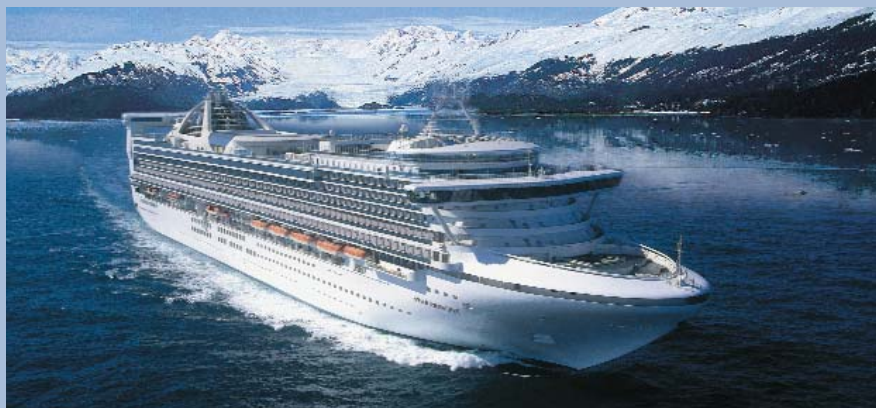
**Star Princess Equipped With COMPAC Water Lubricated Propeller Shaft Bearings Since 2002**

pollution or subsequent environmental violations that could result from stern tube oil leakage, however small. There are currently over 380 Commercial and Naval vessels that are equipped with Thordon COMPAC water lubricated propeller shaft bearings plus many more on order. **Nw**
