Vertical Lift Pumps Now Fitted With Grease-Free SXL Bearings

During a routine statutory shutdown of PetroSA's offshore FA Platform in Mossel Bay, South Africa, existing rubber bearings in the vertical main seawater lift pumps were replaced with Thordon grease-free SXL pump bearings. The statutory shutdown is part of PetroSA's operating permit which allows opportunity for inspection and repair of critical equipment in order to ensure its integrity.

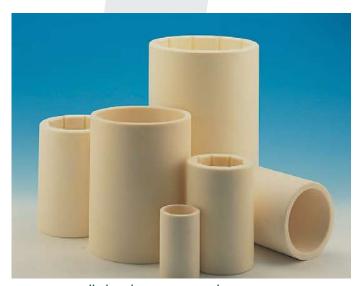
Easy to install Thordon SXL pump bearings

Thordon SXL pump bearings are easy to machine and install. The bearings were machined at a local machine shop to sizes that were generated by the Thordon

Bearings Sizing Calculation Program and dry ice was used for quick and easy installation of the bearings into the housing. PetroSA was on hand to witness the first bearing being installed and to verify the fit of the bearing into the housing. With the success of this project, PetroSA are looking at other applications to incorporate Thordon grease-free SXL bearings. **NV**

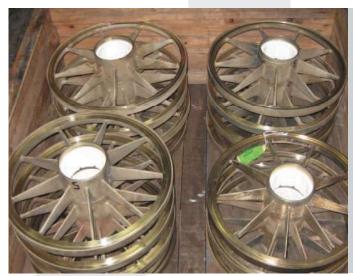
Thordon SXL pump bearings installed into existing bronze
